The Landslide at Anargyroi

MINE SHIFT: EXAMINING GROUND DISPLACEMENT IMPACT ON MINES AROUND THE WORL

The Amyntaiou Lignite Mine

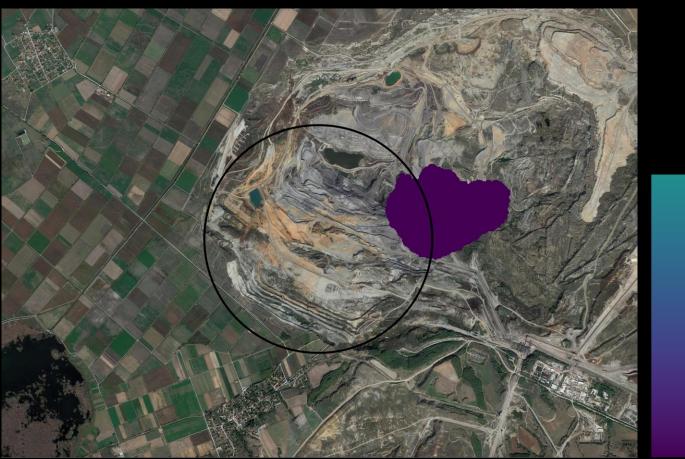
Fig.1 Horizontal Movement - 6 March 2017

To show it in action, our team used historical satellite imagery of the Amyntaiou area dating back six months before the landslide and combined it with CATALYST InSAR analysis to determine displacement levels across the site. Interestingly, just as the local community had reported, movements were detectable even then. In Fig.1 there's clear evidence of both horizontal (purple) and vertical (red) cumulative displacement visible at both the south westerly and north easterly areas of the mine, which we tracked from 1 January 2017 to 6 March 2017.

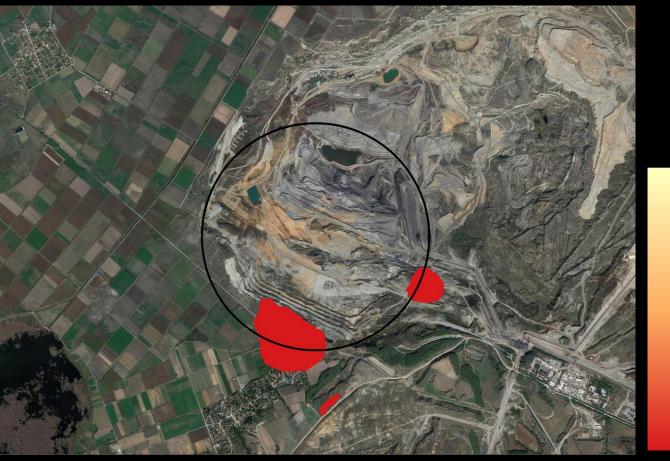
Fig.1 Vertical Movement - 6th March 2017

The individual displacements recorded may only be mm-level movements but are considered 'extreme' due to the size and speed of change. The areas of 'normal' movement have been filtered out of these views to highlight the areas of most concern.

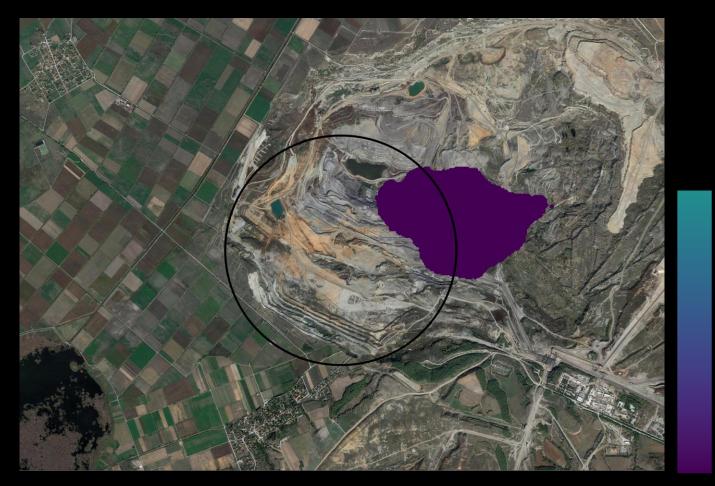
Fig.2 Horizontal Movement - 11th April 2017

This is what it looked like five weeks later, with increased east to west movements in the north section section of the mine as well as growing vertical movements (movements towards the centre of the earth) in the south west area.

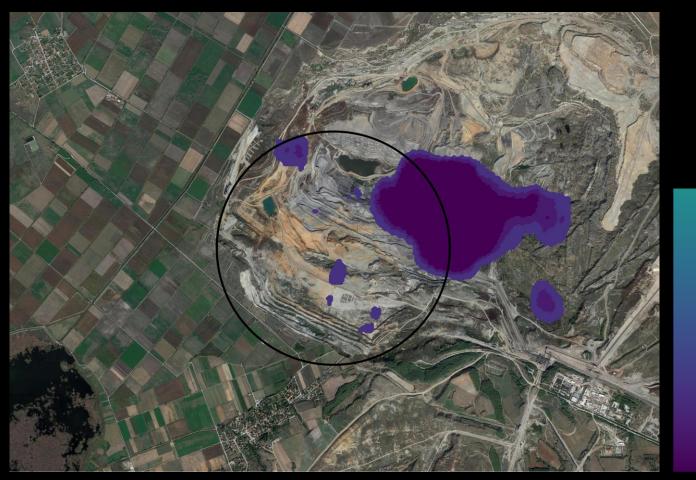
Fig.3 Horizontal Movement - 29th May 2017

Just weeks out from the event, it's clear how much the rate of displacement increased with each day, with both areas of the mine experiencing significant and sustained movement.
